# VAN ASSELT SCHOOL ADDITION /

Seattle Landmarks Preservation Board  
Architectural Review Committee Meeting

November 13, 2020

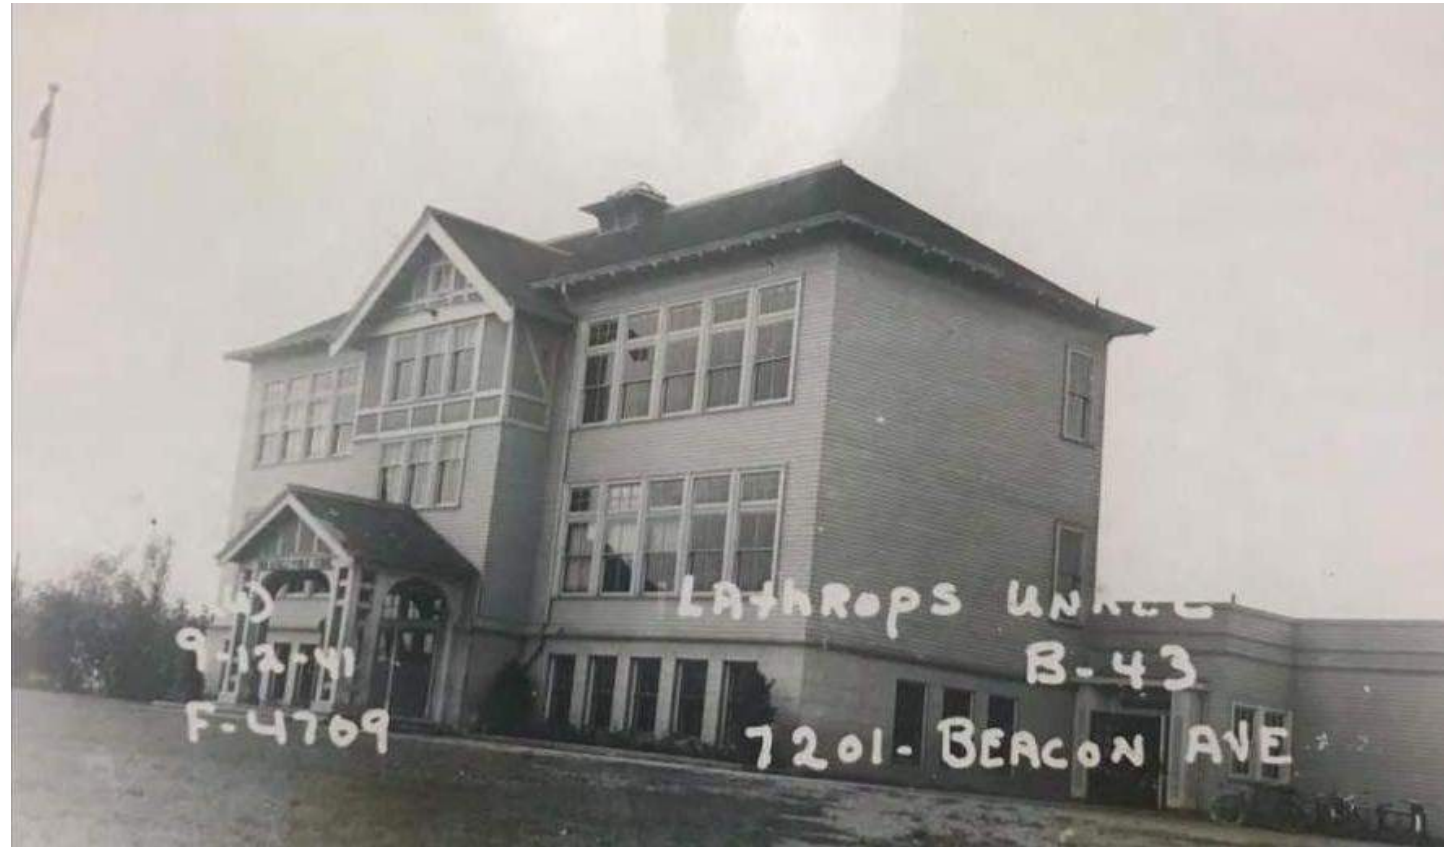
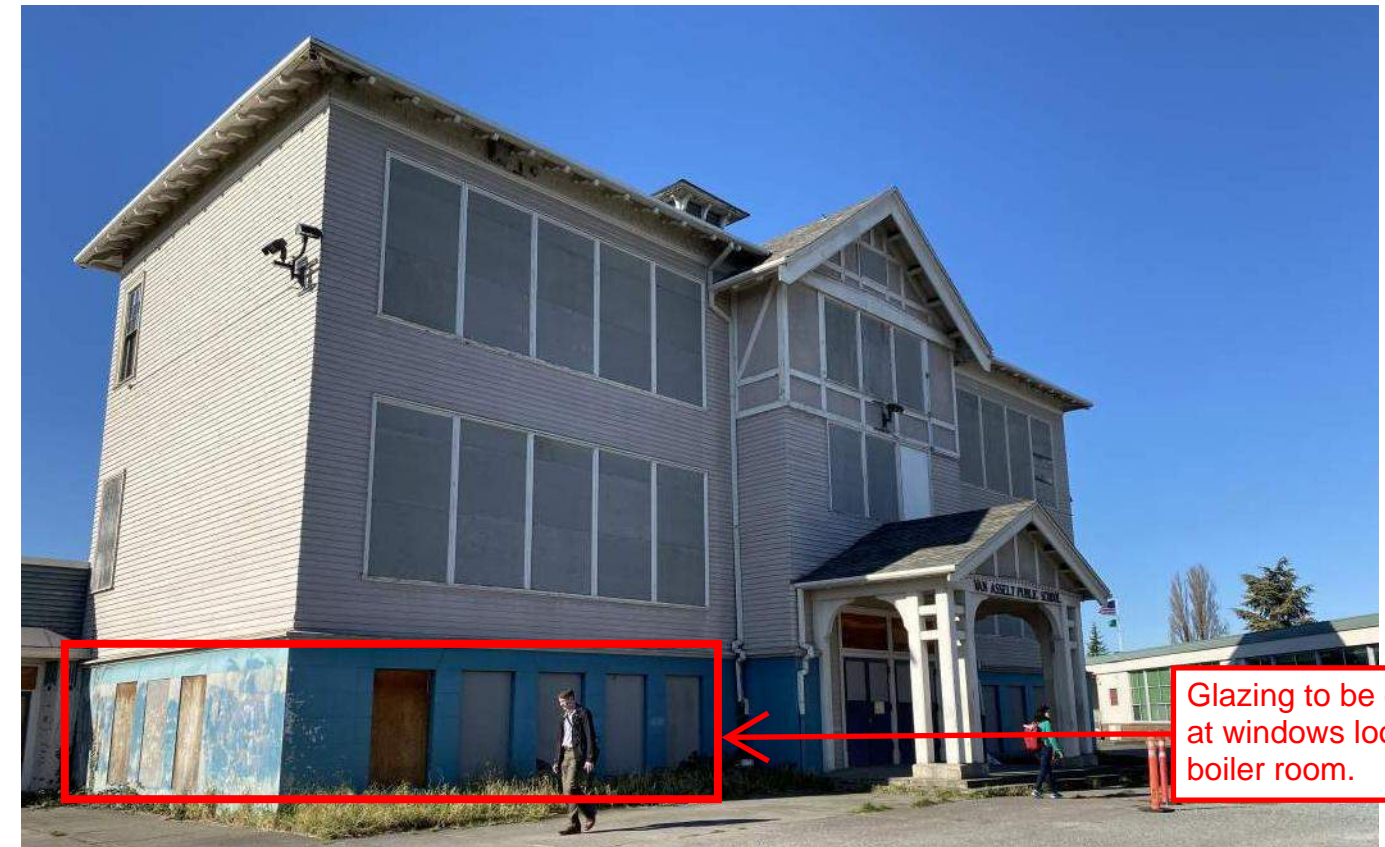
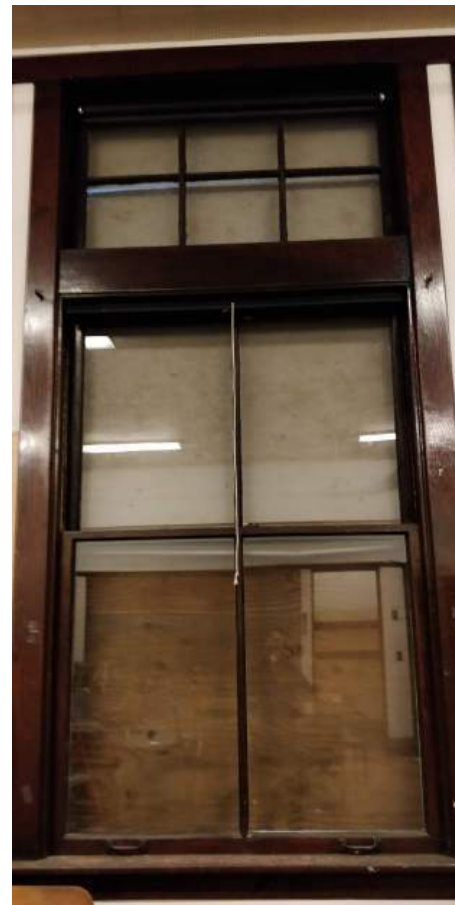
# WINDOWS

VANDAL PROOF METAL MESH

## Window Restoration Scope of Work:

- Removing or encapsulating asbestos containing glazing putty
- Painting exterior frames and sashes (color TBD)
- Replacing hardware or fixing window sash in place
- Replacing broken glazing with in-kind material
- Adding new weather stripping
- Removing and patching surface rot
- Replacing rotten wood members for windows with structural deficiencies
- Finish touch up on the inside frame, sashes, and wood trim
- Obscure glazing at basement floor windows at the south and southeast facade (looking into the boiler room).
- Install vandal proof metal mesh at all basement floor windows (interior side) - except for south basement level windows.

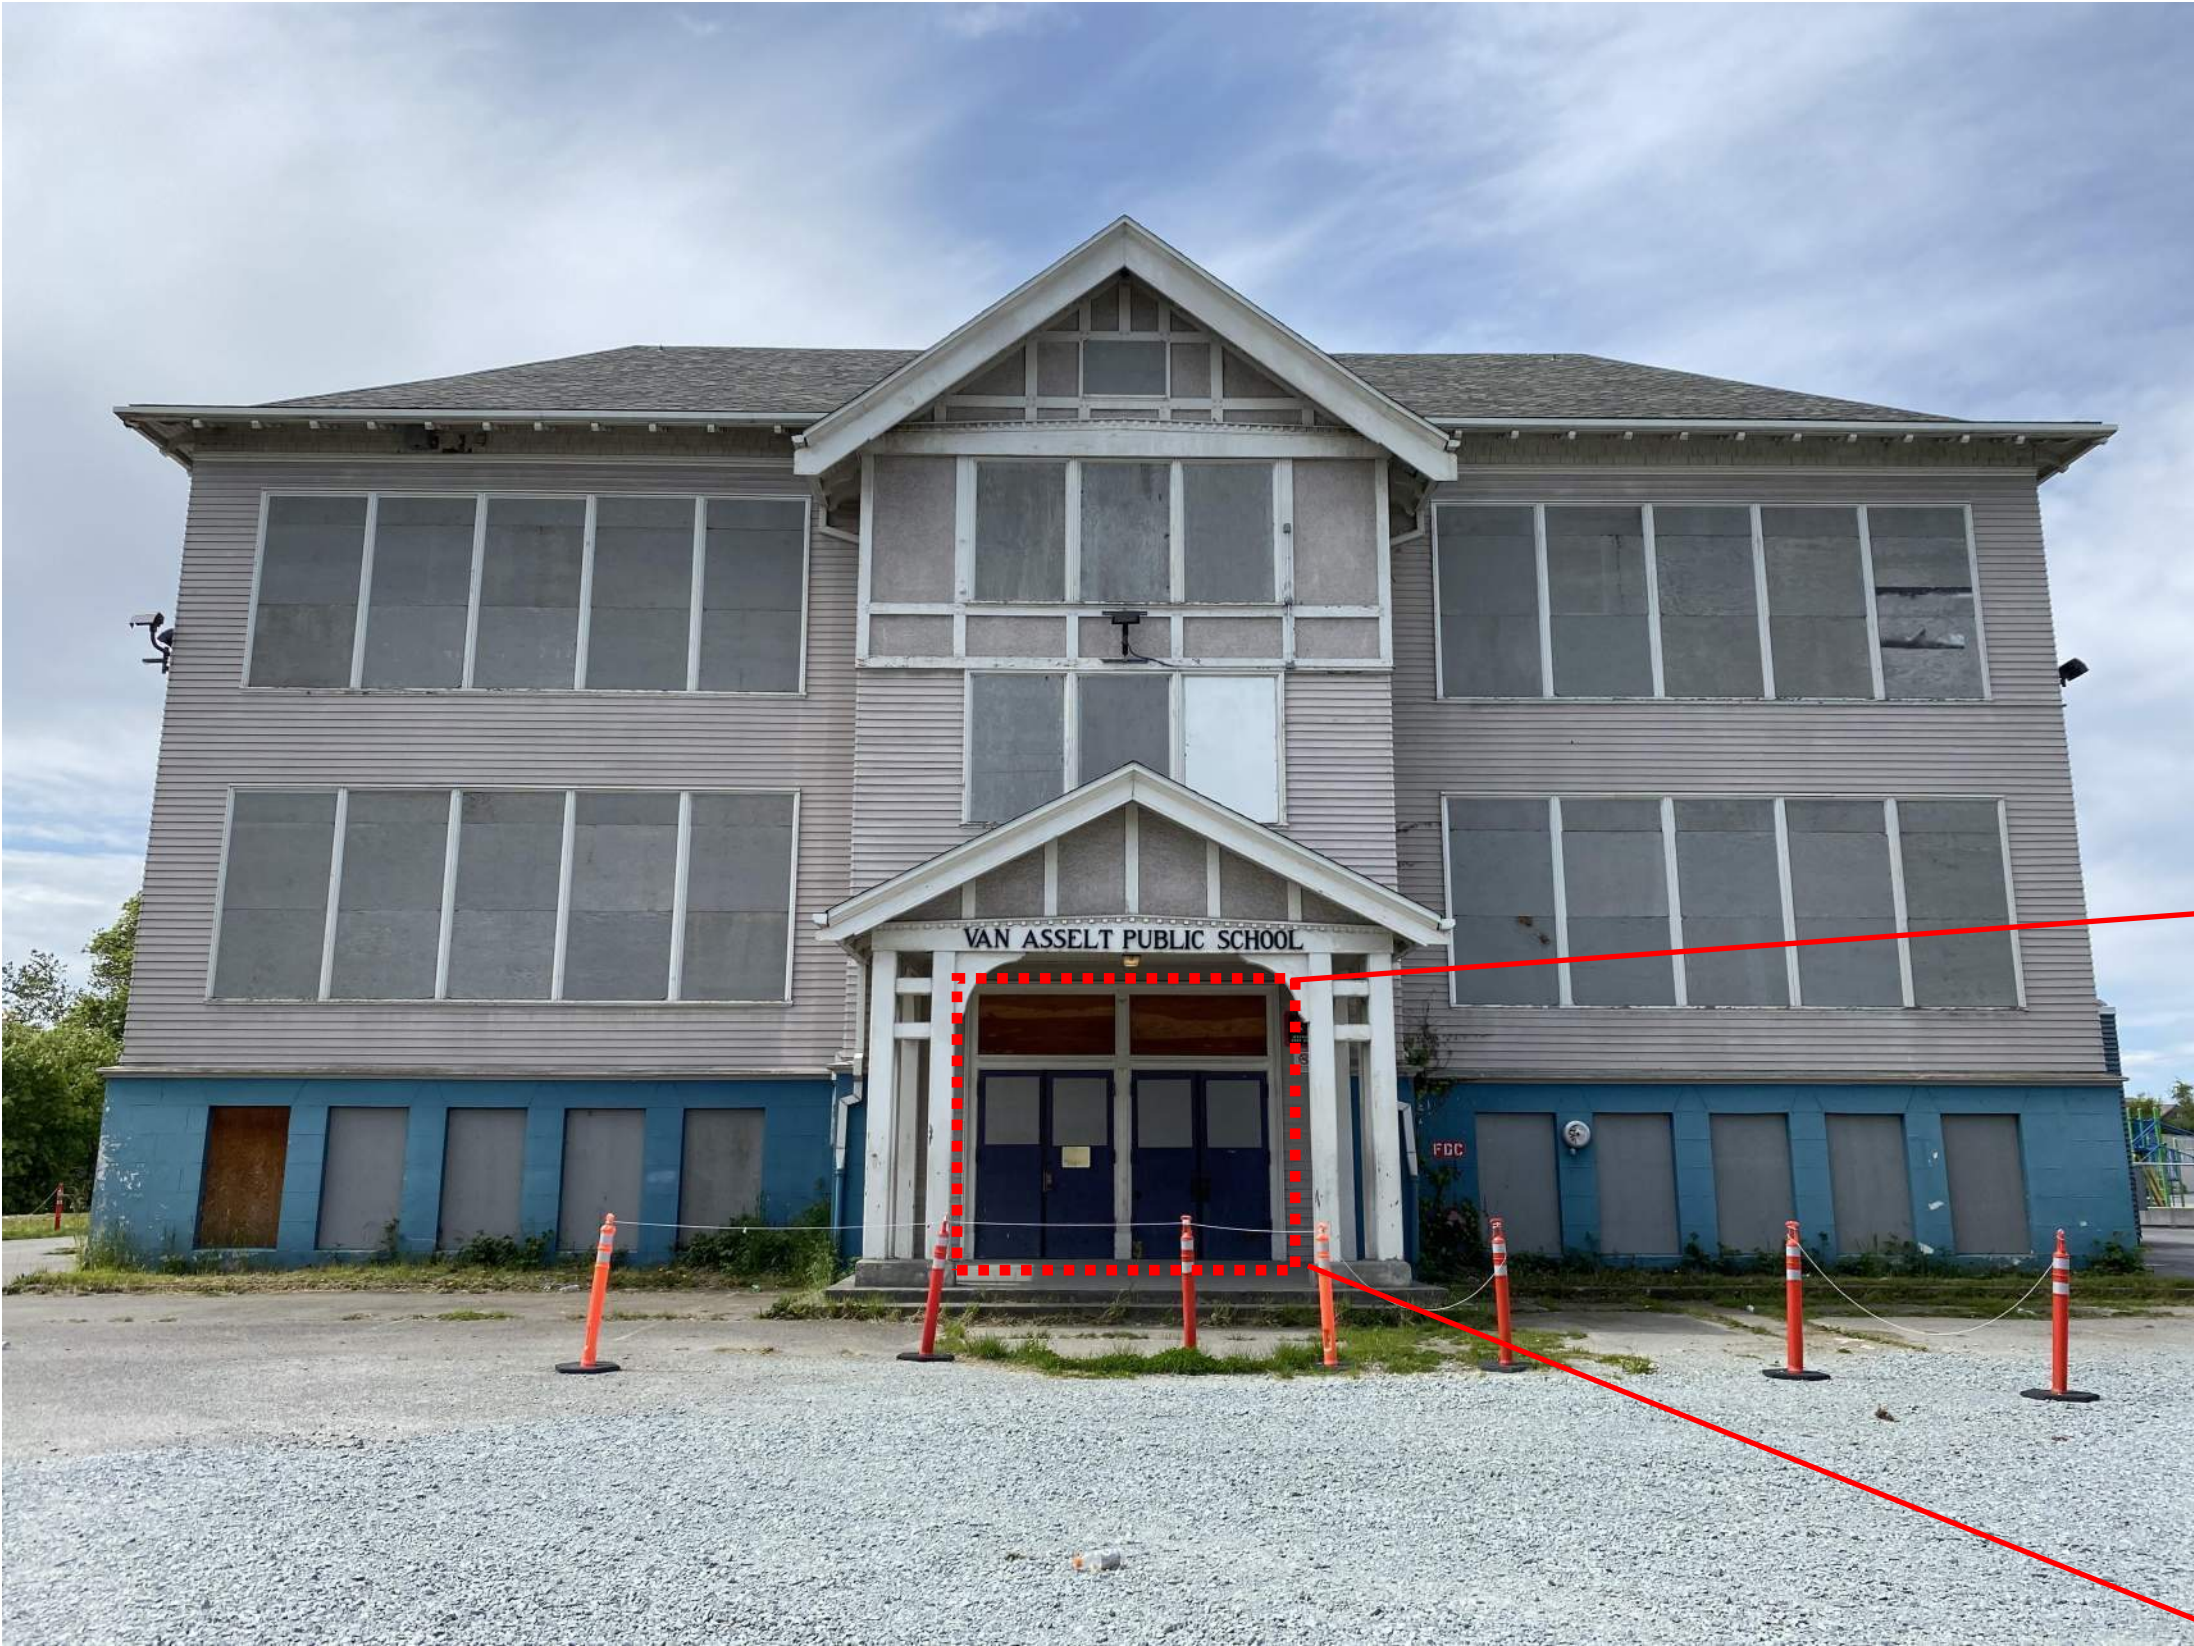
# EXTERIOR ENVELOPE

## Exterior Envelope Scope of Work:

- Patching or replacing damaged wood siding with in kind material.
- Repainting siding, fascia boards, and wood trim (color TBD).
- Repainting concrete foundation walls (color TBD).
- Replacing exterior doors to match original panel and half-light; Providing hardware per district standards.
- Removing (3) exterior modern light fixtures (flood lights) from the face of the building.
- Preserving existing sign 'Van Asselt Public School'.

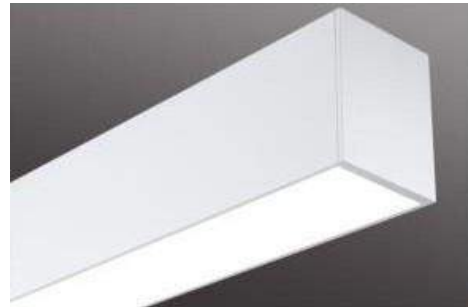
PENDANT LIGHT FIXTURE

- Install new light fixtures
- Install new power and data
- Install new projector at teaching wall
- Route electrical systems through wall/ceiling cavities where practical; some exposed systems may be required.

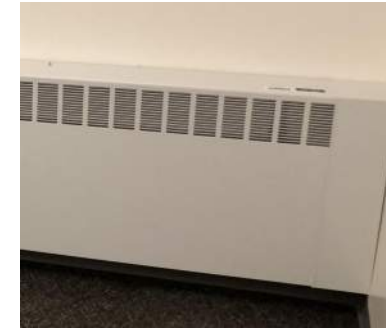
RADIATOR

- New ventilation grills located at top of west wall.
- New radiator located at east wall below the window sills.
- New ducts located in Support space.
- Sprinkler system to be exposed at ceiling.

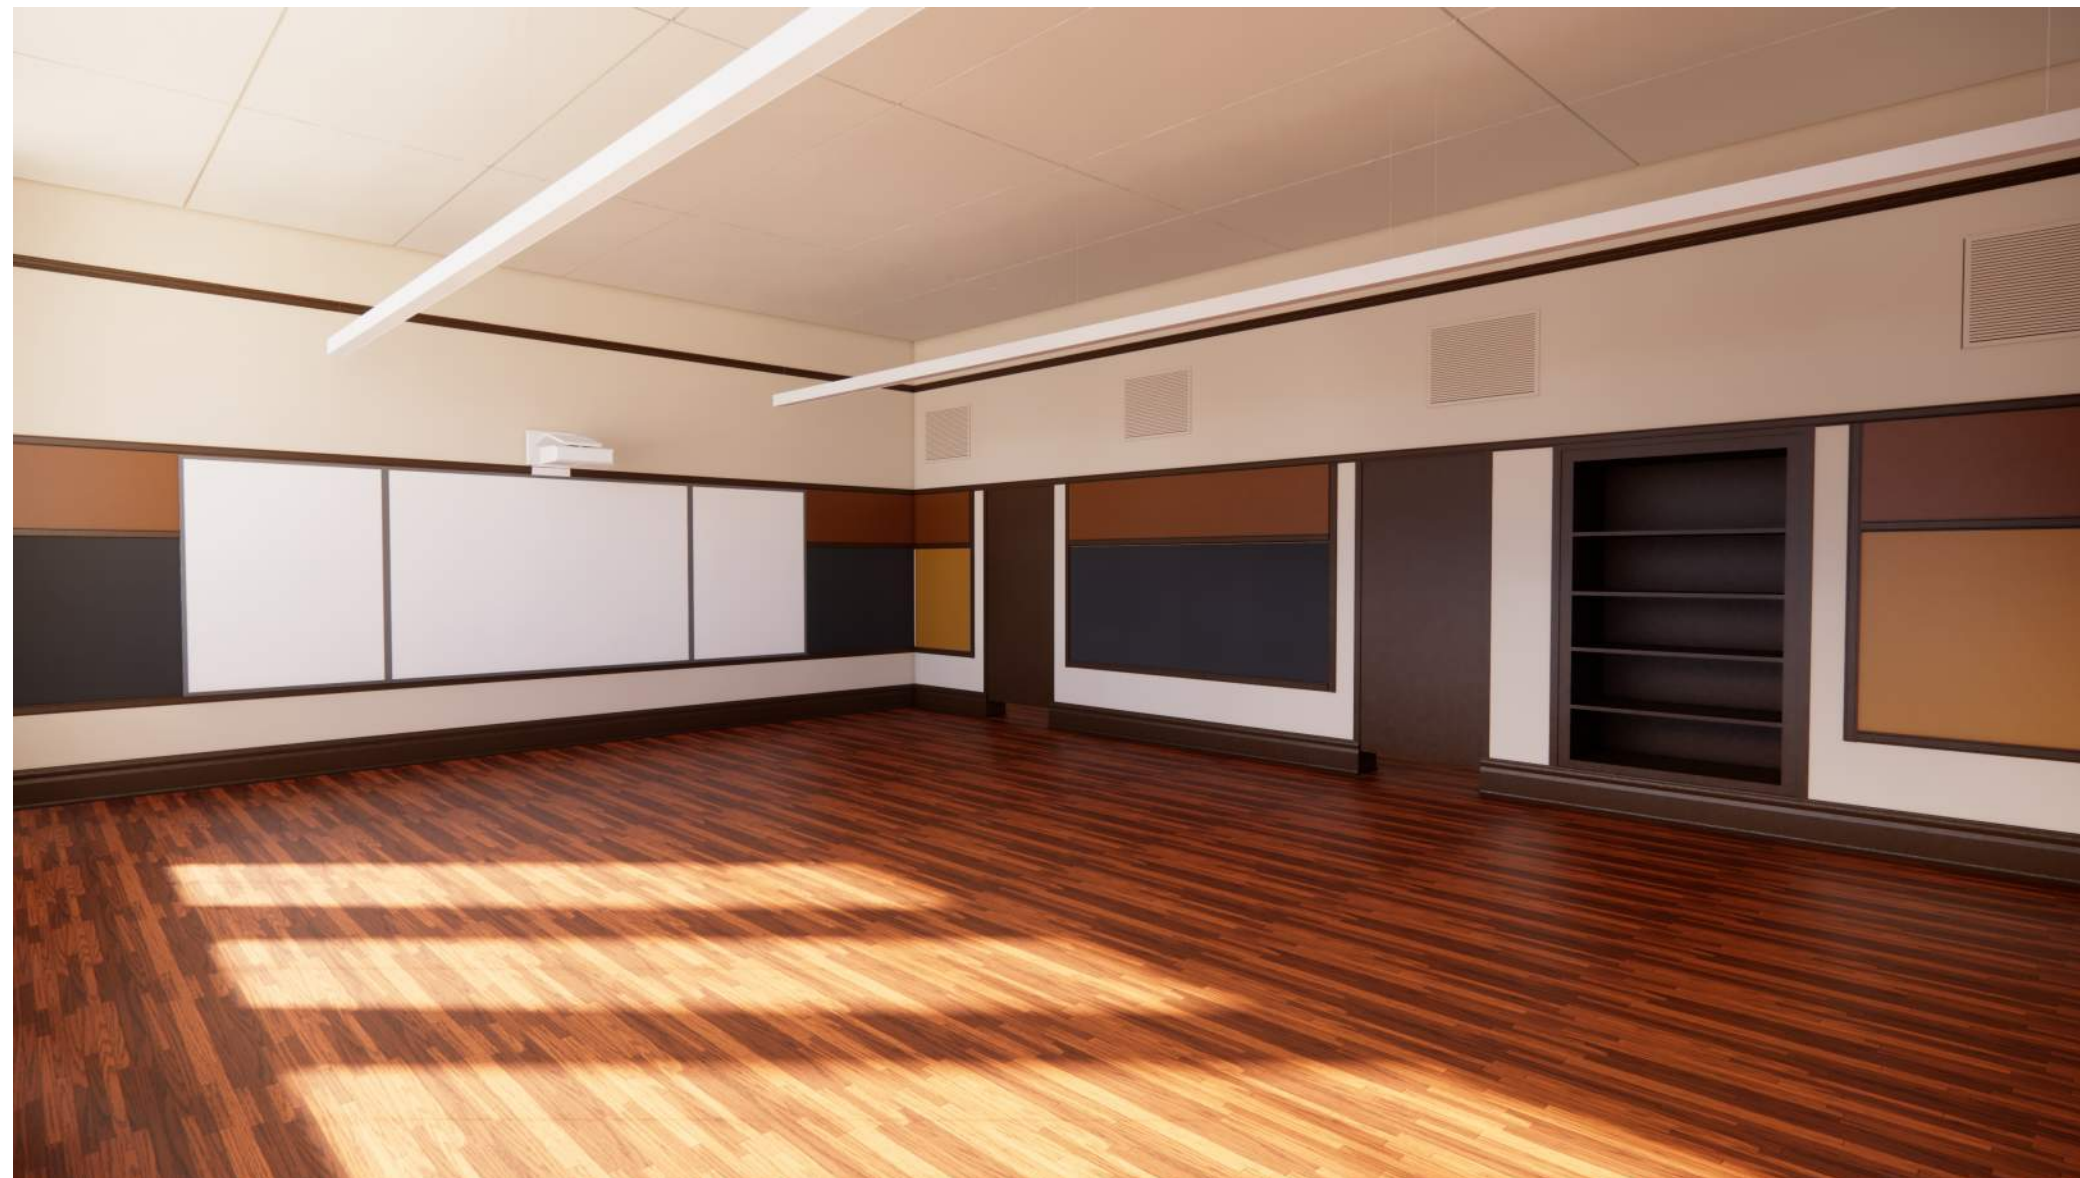
CONCEPT RENDERING OF RESTORED CLASSROOM

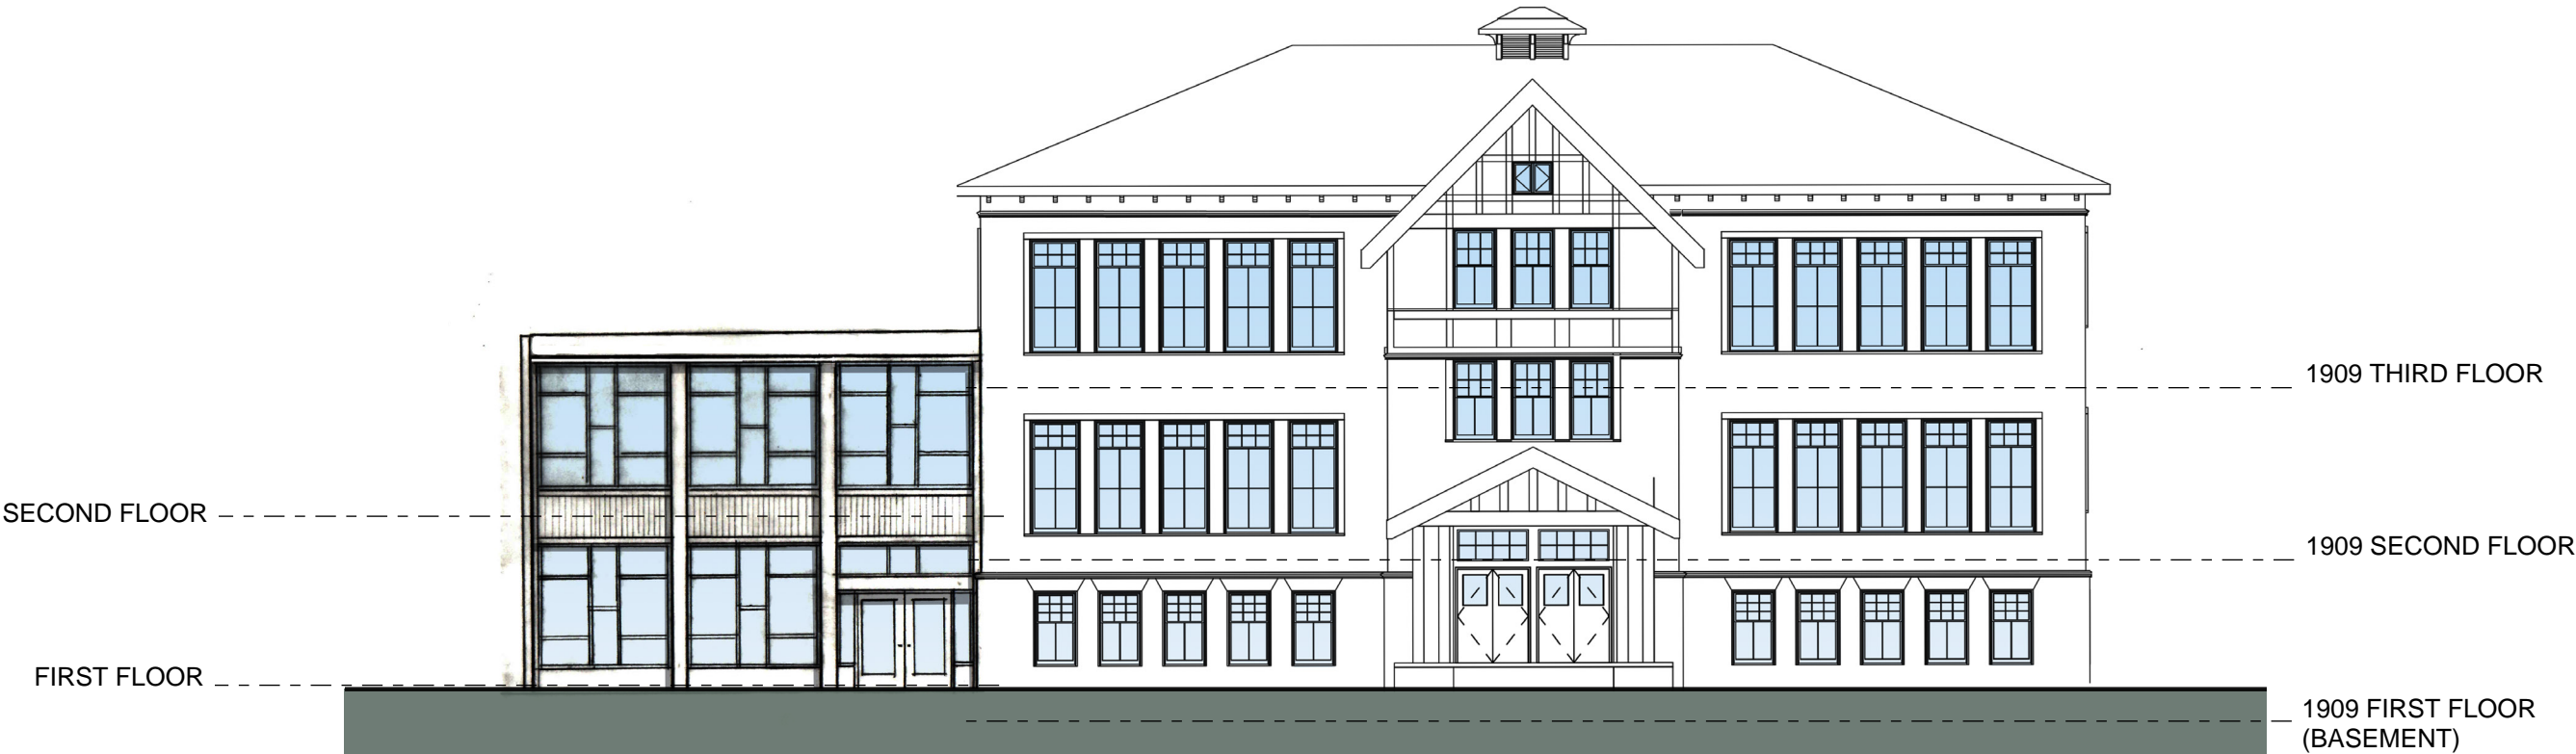
EAST COURTYARD ELEVATION - ENTRY

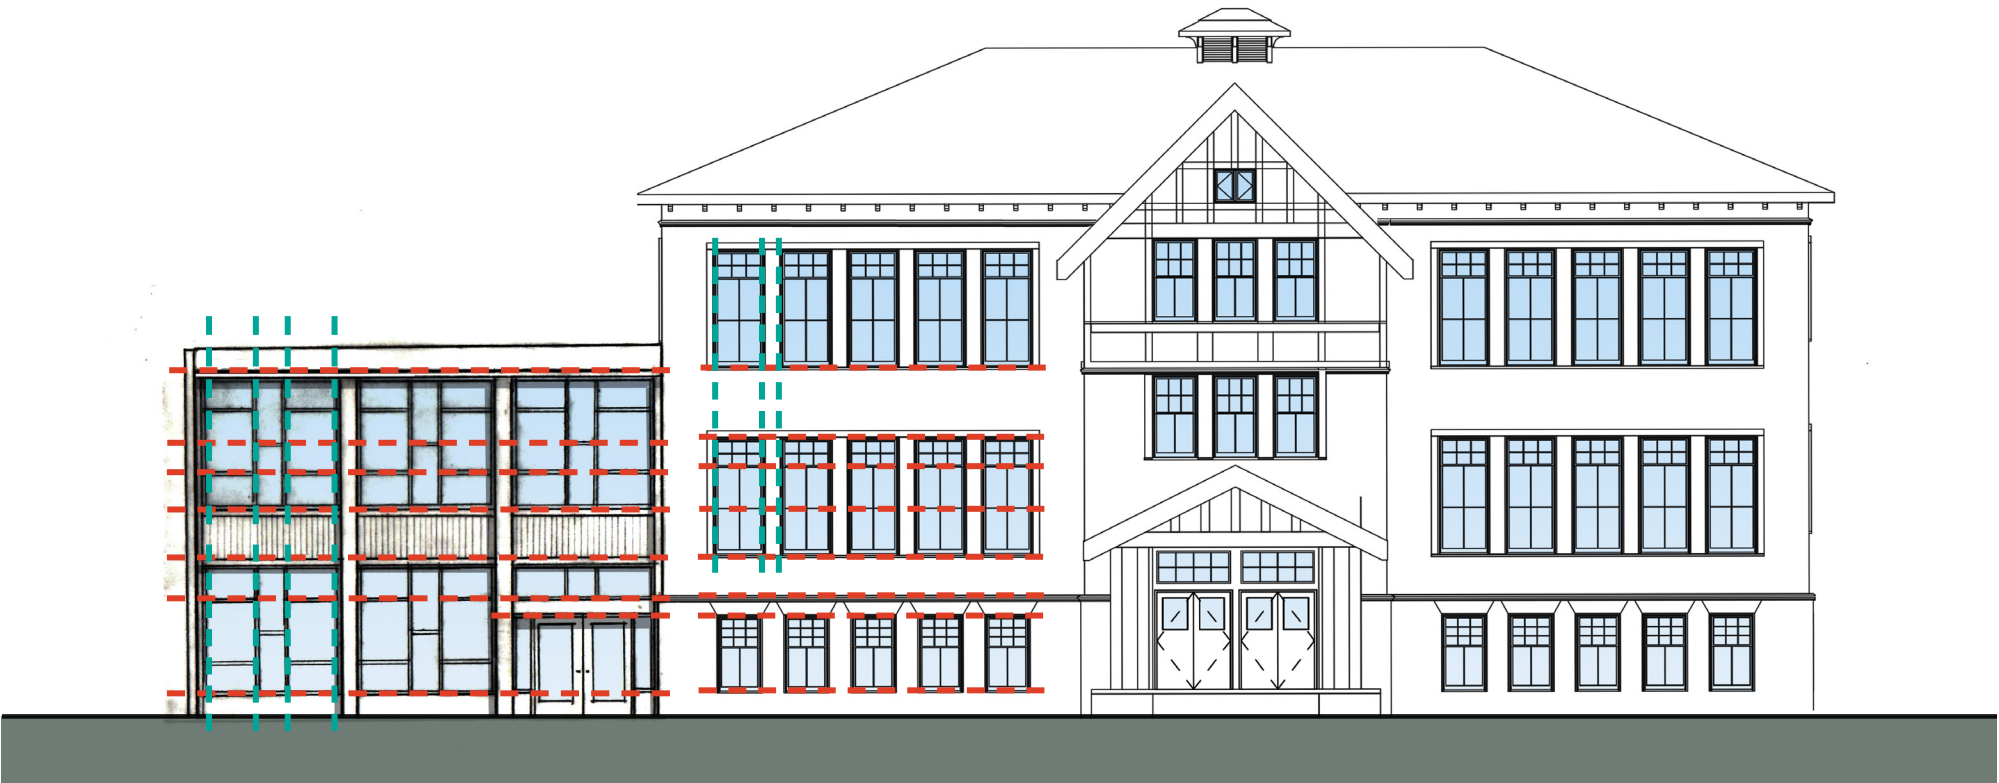
EAST COURTYARD ELEVATION - DATUM STUDY
